OIL INDUSTRY SAFETY DIRECTORATE

Case Study: Coker Unit Incident during un-heading operation (semi-automatic) at one Indian Refinery

V.J Rao / M. Gupta

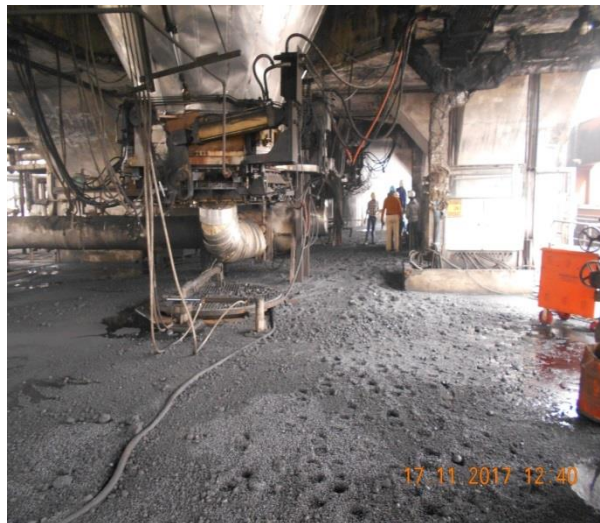
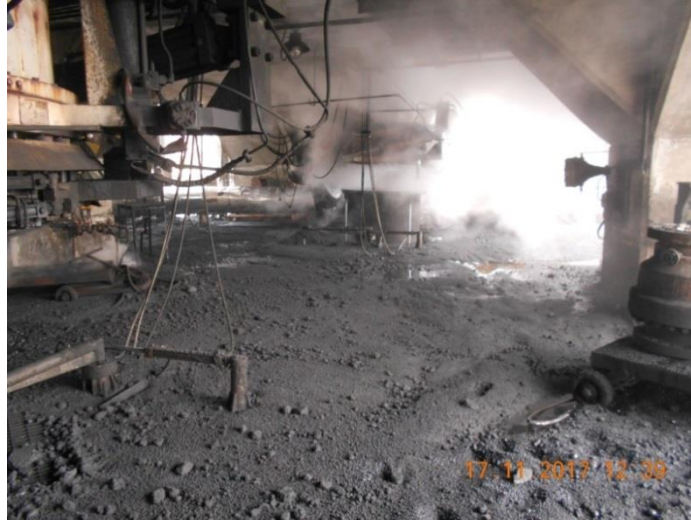
- i) Just in the beginning of next sequence during un-heading i.e. bottom cover swing operation, the shot coke and hot water suddenly gushed out and spread out in the switch deck platform. Some of the shot coke and water spilled over to the ground level near the staircase area adjacent to the lift.

Shot Coke and water spilled on the Switch Deck Platform

- The spillage could not be contained at the switch deck platform at 20M elevation due to inadequate barriers and got spilled over to the ground floor

- 2) The coke drum area at ground floor level should be covered under CCTV surveillance.
- 3) The containment of coke spillage during un-heading is to be ensured by providing necessary removable type metal barriers around the chute so that any coke and hot water spillage is directed towards the coke pit.

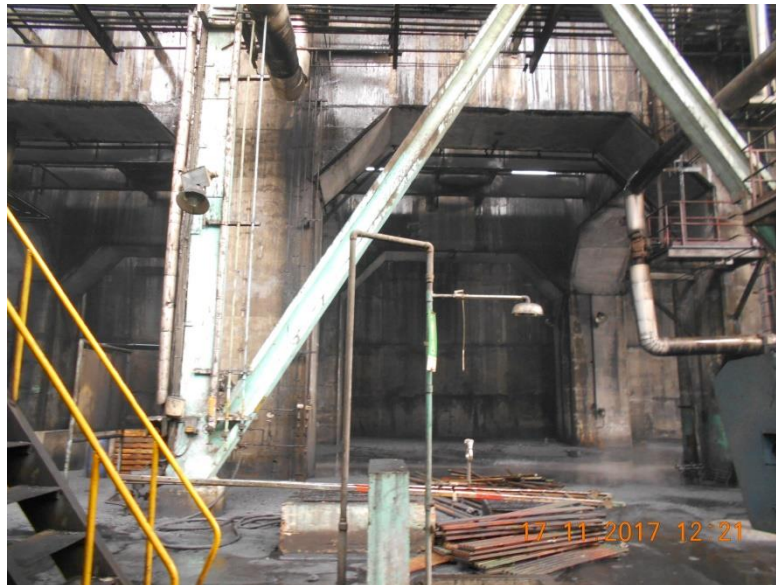
m) The safety shower at the ground level was not available at strategic location.

Safety shower location
