## CASE STUDY- MAJOR FIRE IN A MS PIPELINE AT A PORT LOCATION

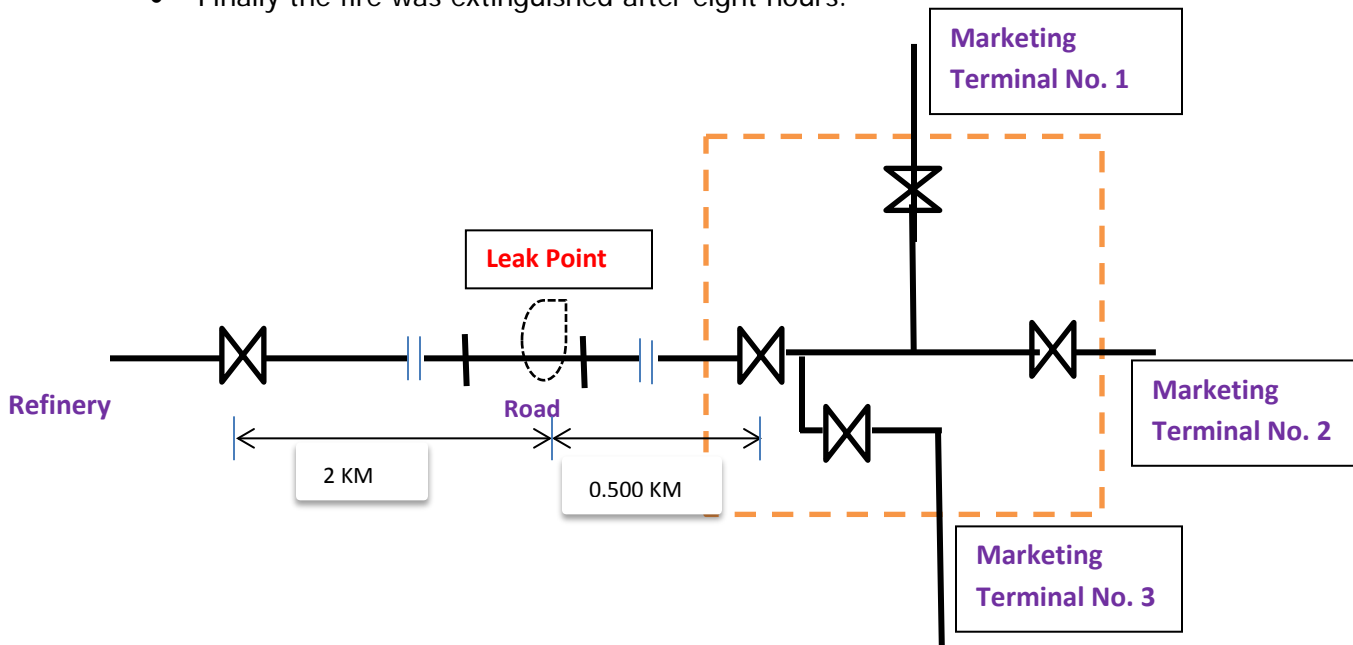
***SCHMATIC SKETCH OF THE PIPELINE & LEAKAGE POINT***

- The leak in the 14" OD line caused substantial spillage of MS; the spilled oil got mixed with the water in the adjacent creek & spread to nearby areas due to tidal effect.
- Gully sucker & other firefighting accessories etc. were mobilized to recover the oil from the creek,
- Flushing of the associated lines was started to undertake the repair of the line. After sometime when it was observed that the leakage of product increased substantially the flushing operation was stopped,
- A major fire took place at about 100 M away from the leak spot; fire tenders were put into service to fight the fire,
- Fire was put under control but kept on re-occurring intermittently,
- Finally the fire was extinguished after eight hours.

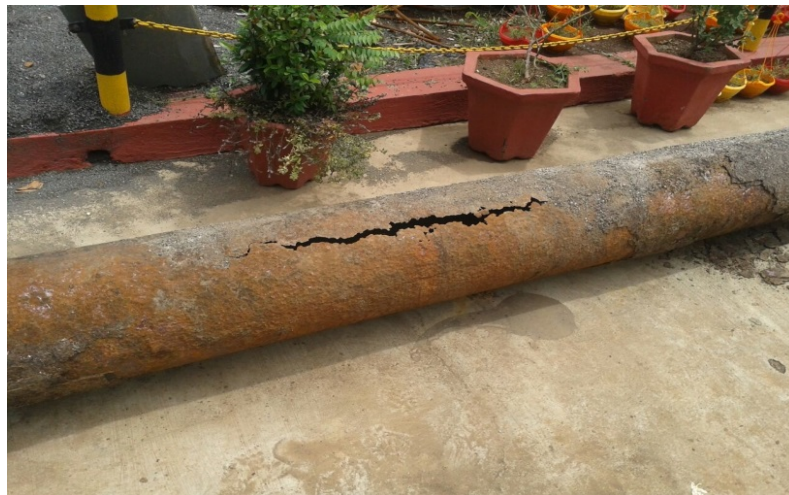
- The thinning of the pipeline, as may be seen from the attached pic, indicates uniform external & internal corrosion, across the longitudinal section of the pipeline, was taking place for prolonged period of time.

**A VIEW OF SEVERELY CORRODED PIPE**

- The uniform paper like thinning of the pipe indicates corrosion for a prolonged period of time. The corrosion in the pipeline is attributed to both internal & external corrosion; not providing cathodic protection system coupled with no external coating on the line made it vulnerable against external environment. It may be pertinent to note that nearer to the sea location indicate that the soil resistivity is low which enhances the rate of corrosion. The internal corrosion in the line is attributed to use of saline (sea) water as flushing media. Further in absence of periodic planned M&I activity such as direct corrosion assessment tests (hydro test, thickness measurement etc.,) the extent of damage in the line could not be assessed till the same failed.
- Since there was no external coating in the underground pipeline, it caused severe external corrosion of the pipe.

- Proper painting of above ground pipes shall be carried out at regular intervals; the saline environment hastens up the external corrosion & application of suitable paint would reduce external corrosion.

- Underground pipes shall be provided with suitable external coating such as 2-ply/ 3-ply cold tape, PU coating, High Build Liquid Epoxy etc.,
- Sleeves shall be provided in all the road crossings after putting a corrosion resistant paint for strengthening the pipe. This would prevent cyclic load on the pipe segment while vehicles pass over the crossings.

- Corrosion probes/ corrosion coupons shall be provided for monitoring the rate of internal corrosion. Corrosion inhibitors may be used in the pipeline, if the internal corrosion rate exceeds 1 mpy.

- Flushing of pipeline with sea water must be dispensed with. In the event line flushing is absolutely necessary, must be done with fresh water or ideally kept with product fill; in the later case, necessary accounting must be done.

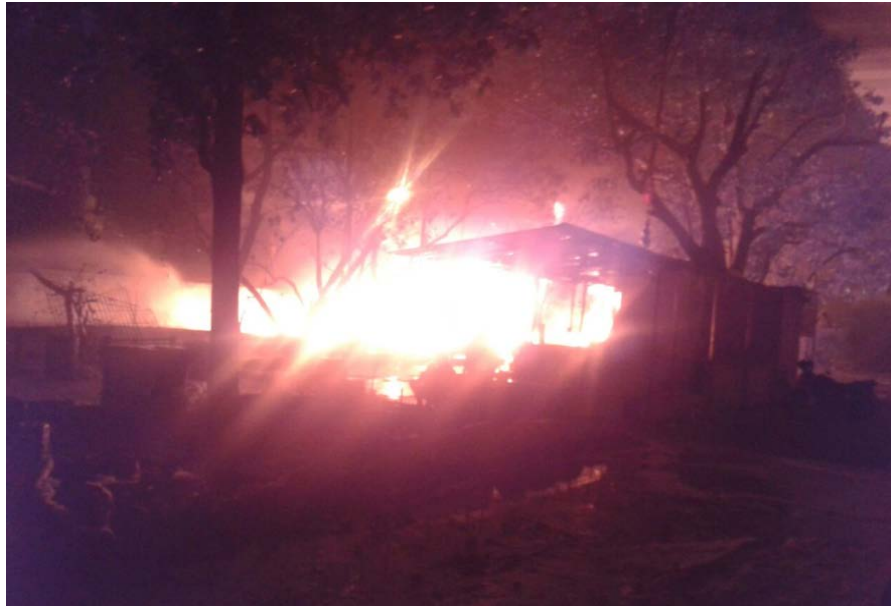
After the failure of the pipeline, the leaked product, MS got mixed with the water in the adjacent creek. It was raining heavily and due to the tidal effect MS got spread up and flowed to nearby mangroves field, which was already flooded with water. It was reported that a passer-by lighted a bidi, which provided the ignition.

**THE FIRE AFFECTED AREA**

- Considering, the fact that there was cluster of product tanks near this pipeline, risk analysis shall be carried out for product transfer/receipt lines and necessary remedial measures may be taken.
- Periodic mock drills must be conducted for effective handling & preparedness of emergency situations.
