Case of MS tank Fire - Is it knowledge gap?

1. The incident

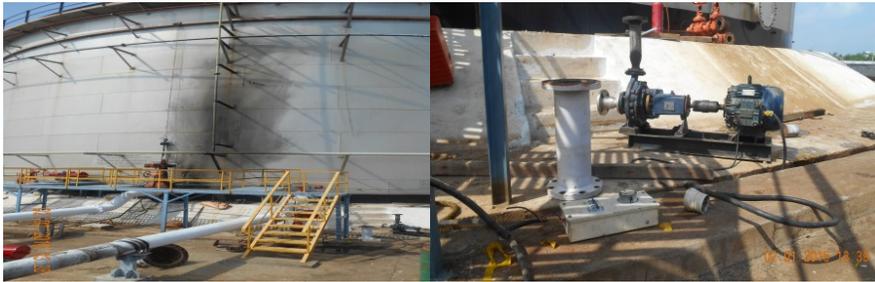
Fire mark at the affected tank nozzle; Non-flame proof electrical JB

The photographs above indicate the fire mark at the tank nozzle area and use of prohibited non-FLP electrical JB inside dyke area.

- ❖ *Pump motor (FLP) was used for transfer of left over tank bottom MS. Electrical JB (non FLP) with burnt cables and burnt hoses were lying inside the dyke area at close proximity of the valve manifold. Cable connections to JB were without double compression gland and observed to have gaps at cable entry. The electrical motor was found not earthed.*

- ❖ *Electrical JB was kept within 2-3 meters from the tank nozzle valve where MOV was removed.*
- ❖ *Pump suction to tank water draw off line was connected using rubber hose. However, hose connection from pump delivery to TT compartment was partly rubber make and partly plastic make towards end connection into the TT compartment.*

The most likely cause of the fire is due to propagation of vapour from inside the tank immediately through the open nozzle (after removal of MOV) which came in contact with spark emanated from non-FLP electrical JB/Connections during transfer using pump motor set to tank truck. *It may be mentioned that use of Non FLP electrical JB together with loose electrical termination joint inside the dyke for emptying out the tank is gross violation of SOP.*

- ❖ Simultaneous activities involving pumping out of highly volatile Motor Spirit with improper & not-fit-for-the-purpose equipment with source of ignition at close vicinity to Hydrocarbon vapour is a strict **NO**. In this case, while dropping of tank Body MOV, electrical source was operated on/off in close proximity of MOV which is not only risky but highly unsafe.
- ❖ Non FLP electrical JB together with loose connections is strictly prohibited inside tank farm area or at any other area/equipment having possible source of hydrocarbon.
- ❖ Electrical JB, even if it is FLP type, should be kept much away from the source of hydrocarbon at upwind direction of hydrocarbon source. In this case, electrical JB should have been placed outside the tank dyke area.

- ❖ Wire connections (electrical) to JB and motor must be thru' double compression gland so as to ensure FLP status of the equipment. In this case, cable entry to the JB was observed to be having loose ends.
