CASE STUDY ON FIRE INCIDENT AT VGO-HDT UNIT

1.0 THE INCIDENT:

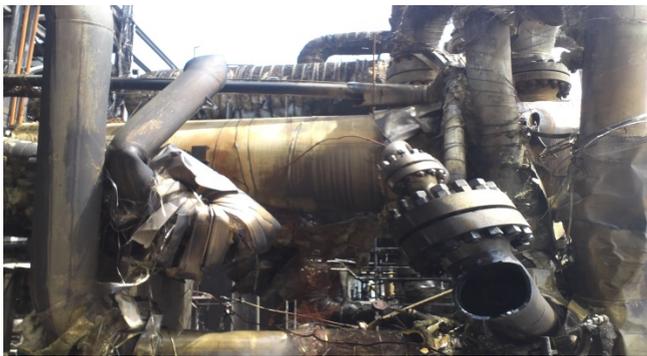
An incident of major fire occurred in VGO- HDT unit of a petroleum refinery leading to shutdown of the unit. Fire continued for about 4 hours. Due to the incident, the unit suffered major damages (shown below) and is under shutdown pending major repairs.

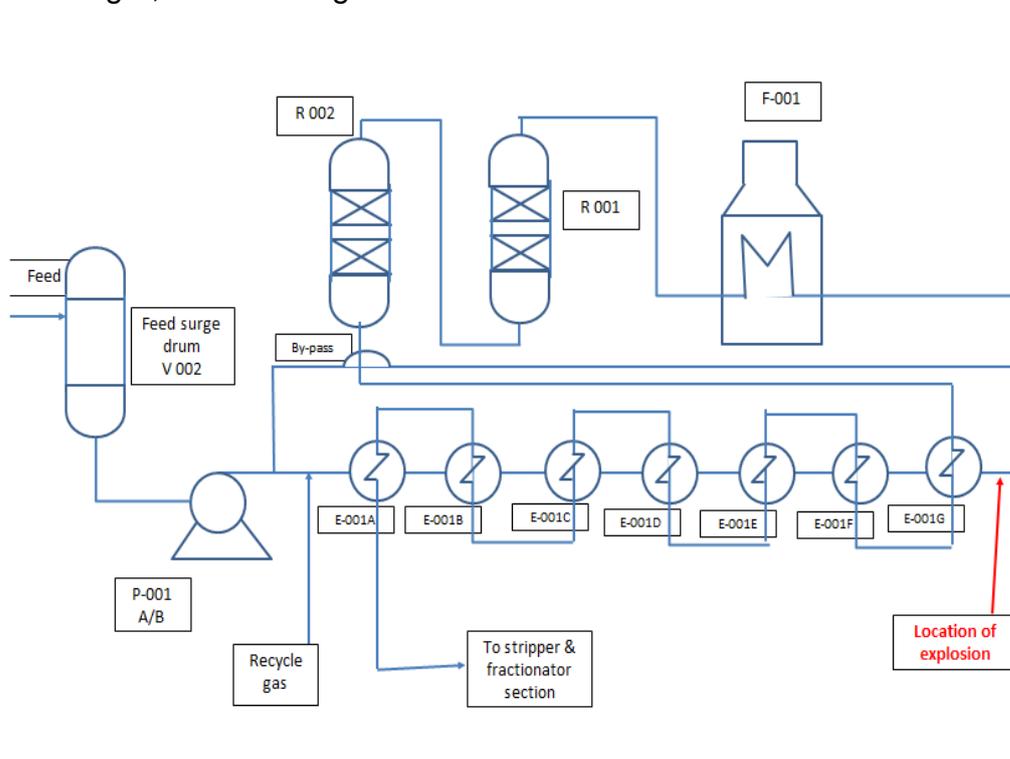
Fig. 1

The explosion took place at the outlet line of VGO Feed/Reactor effluent heat exchanger, shown in Fig.1.

Due to this major explosion, about 40 inch portion of the exchanger outlet line along with part of elbow got detached from its parent piping which flew to a distance of about 20 M. Due to the rupture of the line, there was enormous spillage of VGO and Hydrogen which resulted in a major fire. Also a support (20"NB SS-321 pipe, approx. 1M long) holding this portion of the pipe got detached and was found lying at a distance of about 40M westward. The mainline which got detached is made of stainless steel (SS-321) of 23.8 mm thickness.

- Due to continuous exposure to this high stress, a portion of the pipe (from Quill to part of the elbow) got sheared from both the sides, and got completely detached from its location. The impact was such that ruptured cylindrical pipe was observed flat and was found at a distance of about 20 M near the reactor. The support at the downstream elbow was found detached & blown away to a distance of about 40 Meter due to impact of the explosion.

- To ensure better mixing of hot and cold feed downstream of exchanger, the cold feed is passed through a Quill. As per the design of the Quill, there has to be a minimum length of $10 \times D$ ($D = \text{OD of the main pipe}$) without elbow or Tee. **However, it was observed that the straight length up to the next elbow is only 40 inch compared to requirement of 200 inch.** Not providing adequate length between the Quill and the elbow caused tremendous stress on the main pipe particularly the elbow section which ultimately gave away.

- Inadequate distance between the Quill and the elbow joint. As per design, the straight distance between the Quill and the elbow should be 10 times pipe diameter. At site, the straight length was only 40 inches against 200 inches requirement. Deviation from standard engineering practice of maintaining a clear straight distance ($10 \cdot D$ in this case) after the mixing point (Quill) resulted in continuous stress and erosion at the elbow section which finally gave away.

2. As per P&ID, a minimum straight distance prescribed should be 10D i.e. 200 inch is to be maintained after the Quill. The actual straight distance is only about 40 inch which is far less than the prescribed limit. Inadequate straight length caused the turbulence created in the pipe to exert additional stress (erosion) on the elbow of the pipeline and thus weakening of the section. This deficiency must be corrected upon discussion with Licensor.

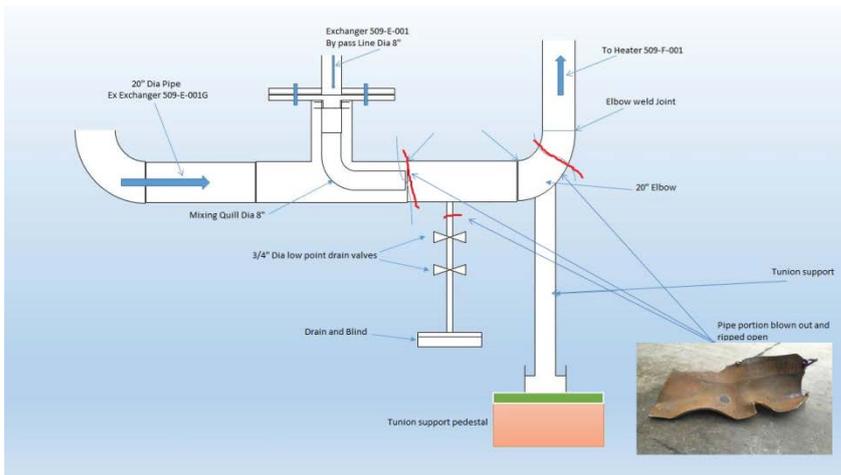
Fig. 2

- The temperature of the hot feed downstream of exchanger was recorded 402°C and the temperature of bypass cold feed was about 200°C. The bypassed cold feed i.e 188 M³/hr joined the hot feed through a Quill and the combined feed was routed to reactor after heating in the furnace.

- Due to substantial higher bypass of cold feed through the Quill and it's mixing with the hot feed at exchanger outlet there must be a rapid turbulence and two phase flow at the mixing point. This is a high severity zone in piping system and the above phenomenon led to extraordinary stress in the downstream piping. The eddy produced due to high turbulence, if not allowed to travel sufficient straight length, upon encountering bend on it's path could have severely damage the pipe structure.

- Thus immediately after the mixing point (i.e. Quill in this case), no restriction zone is provided, by way of adequate straight length of pipeline. It has been observed that the straight length of the line, downstream of Quill was much shorter than the design requirement of 10*D, where D is the outer diameter of the main pipe. Actual straight length was about 40 inch compared to the recommended length of 200 inch (should be 10*D stipulated in the design) causing much higher stress at the elbow downstream to the mixing Quill.

1. Bypassing such huge quantity of VGO (around 41.5 % which is much more than design) should be stopped. Instead, HMEL must conduct a detailed study to identify the exact reason that forced the Operator to

bypass such quantity of cold feed and take adequate measures to resolve this technical issue. Bypassing so much cold VGO led to thermal shock and stress at the exchanger outlet at the location where cold feed meets the hot feed.
