OIL INDUSTRY SAFETY DIRECTORATE
NOIDA

**Case Study: Fire Incident at HSD Fixed Roof Tank in an
Indian Refinery by lightning strike**

-V.J Rao /M. Gupta /Parmod Kumar

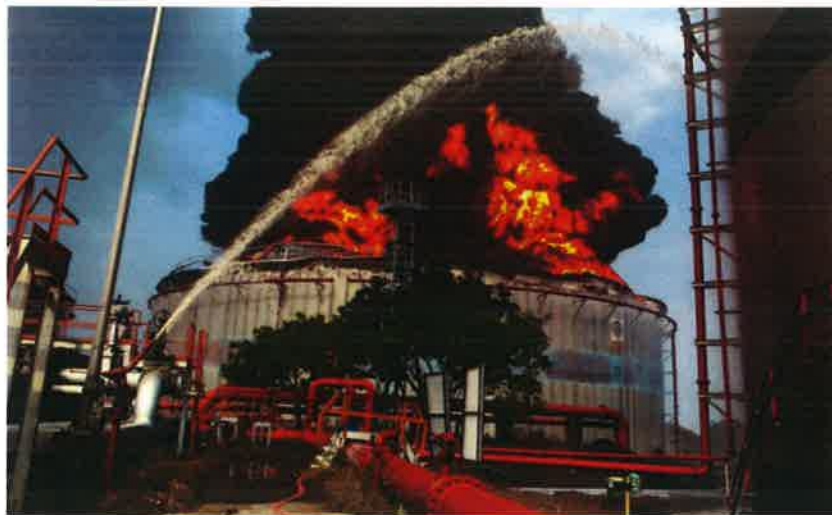
- There was a fire on the top of HSD fixed roof Tank which was surrounded by 2 nos. of HSD tanks and 1 No. of FO tank.
- Fire fighting activities carried out in HSD Tank-A (on fire) along with cooling of adjacent Tanks.
- It was observed that fire water header pressure was about 3.5 - 4.5 kg/cm²g resulting in ineffective fire fighting initially which was subsequently increased to 6-6.5 kg/cm²g
- There was no Disaster Control Room set-up at incident site.
- As the HSD Tank-A was on full surface fire, therefore controlled burning was allowed.

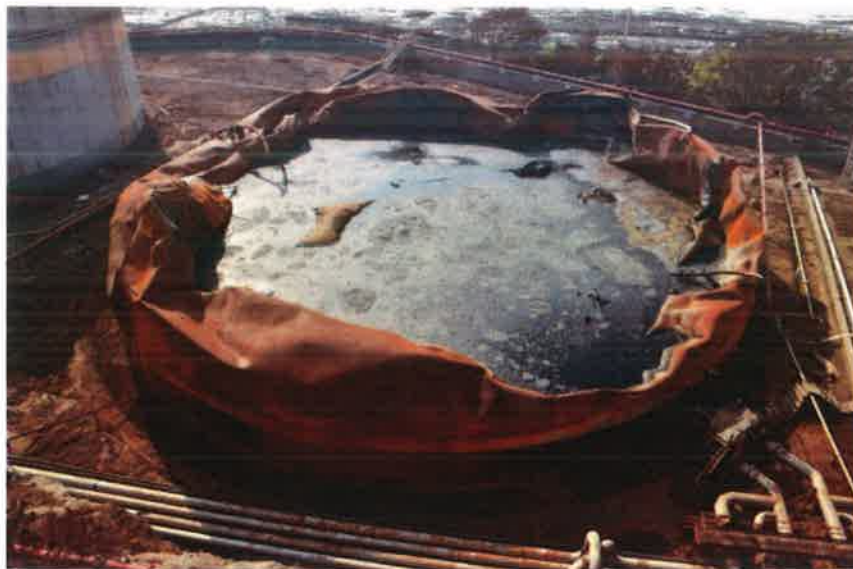
- It was observed that Tank manifold isolation valve was inside the dyke, so positive isolation couldn't be achieved.
- Due to the prolonged fire, Tank-A roof collapsed and subsequently shell got fragmented but bottom two courses of shell was more or less intact.

- Considering the past corrosion rate history of roof plates it can be concluded that the tank- A roof plates were thinned out / pitted.
- The root cause of Tank-A fire was that roof plate thickness must be less than 4.8 mm and got punctured due to lightning strike resulting in fire. As per OISD-GDN-180, the contents of metallic tanks used for the storage of flammable liquids are considered to be inherently self-protecting against lightning if roof has a minimum thickness of 4.8mm.

1. During every external inspection of tanks roof thickness measurement shall be taken as per OISD-STD-129 (*Fixed roof storage tanks to be considered inherently self-protecting against lightning, the roof shall have minimum thickness of 4.8 mm*)

2. M&I of Tank shall be extended after complete integrity assessment of bottom, shell and roof plates.
3. Fire water pressure at the farthest point to be ensured 7 kg/cm² at all the time.
