Crude Oil splash in cross-country crude oil pipeline.

-Shri B.K. Gupta, AD (P&E) & Shri S.K. Bagchi, AD (Asset Integrity)

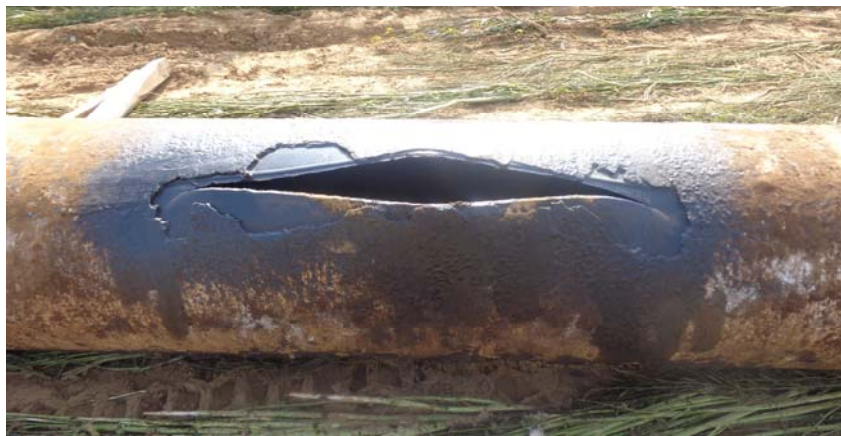
The pic below depicts the fish mouth opening of the pipe between 12 to 1 o'clock position near HAZ of the weld seam. The dimensions of the ruptured pipe are L=1.080 mm; maximum opening in the middle of rupture ~14 mm; metallurgy of pipe LSAW 22" OD, 0.25" WT, API 5L-X-65 grade; provided with Coal Tar Enamel (CTE) coating.

Fish mouth opening of the crude oil line at 12 to 1 O'clock position

UT thickness measurement of the ruptured pipe was taken at different points and general pipeline thickness loss was not observed.

- ✚ Due to parallel closure command to MOV-07 and MOV-01 after sensing the ESD at Terminal Station and a delay of 5 minutes in communicating to upstream Pumping Station for activation of ESD, resulted in generation of excessive pressure/ stress and as a result the failure or rupture of the pipe from the Heat Affected Zone of the pipe weld seam (between 12'O clock to 1'O clock position) at the downstream of pumping station.

- (a) Parallel closure of MOV-07 and MOV-01 after sensing the ESD command at Terminal Station and a delay of 5 minutes in communicating to upstream pumping station regarding ESD of terminal station, might have resulted in excessive pressure/ stress generation at the point of failure because of surge. Surge increases the pressure in the pipeline several folds which got released from the HAZ section of the weld seam.

- (b) Corrosion / any other failure of the pipe due to change of service i.e. handling cleaner product to High S crude oil. Literature survey suggest that High "S" in the crude oil corrodes the HAZ zone near the seam as a result weakens the section thereof.

- (6) Detailed metallurgical / chemical analysis of the ruptured section of the pipe may be carried out from a reputed lab to ascertain the presence of any weld defects such as undercut, porosity, slag inclusion, plate offset, weld seam misalignment etc.,

- (9) The additional tests viz. failure of Sulphide Stress Corrosion Cracking (SSCC) and Hydrogen Induced Cracking (HIC) mechanism must be carried out for the pipeline.

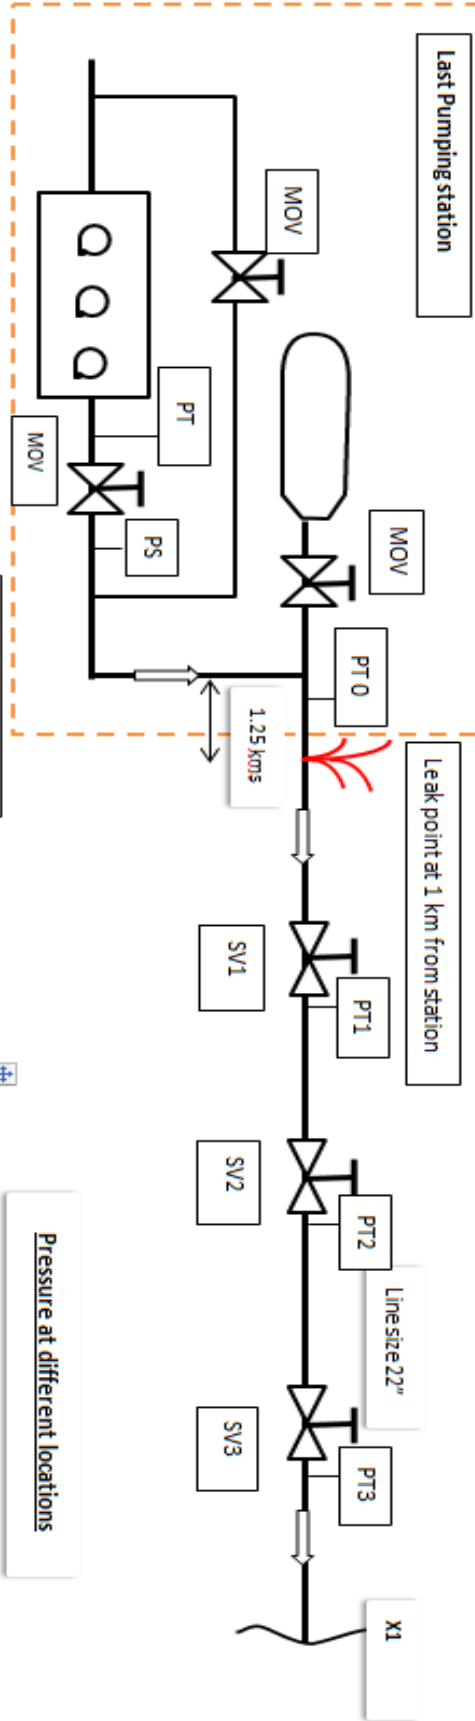
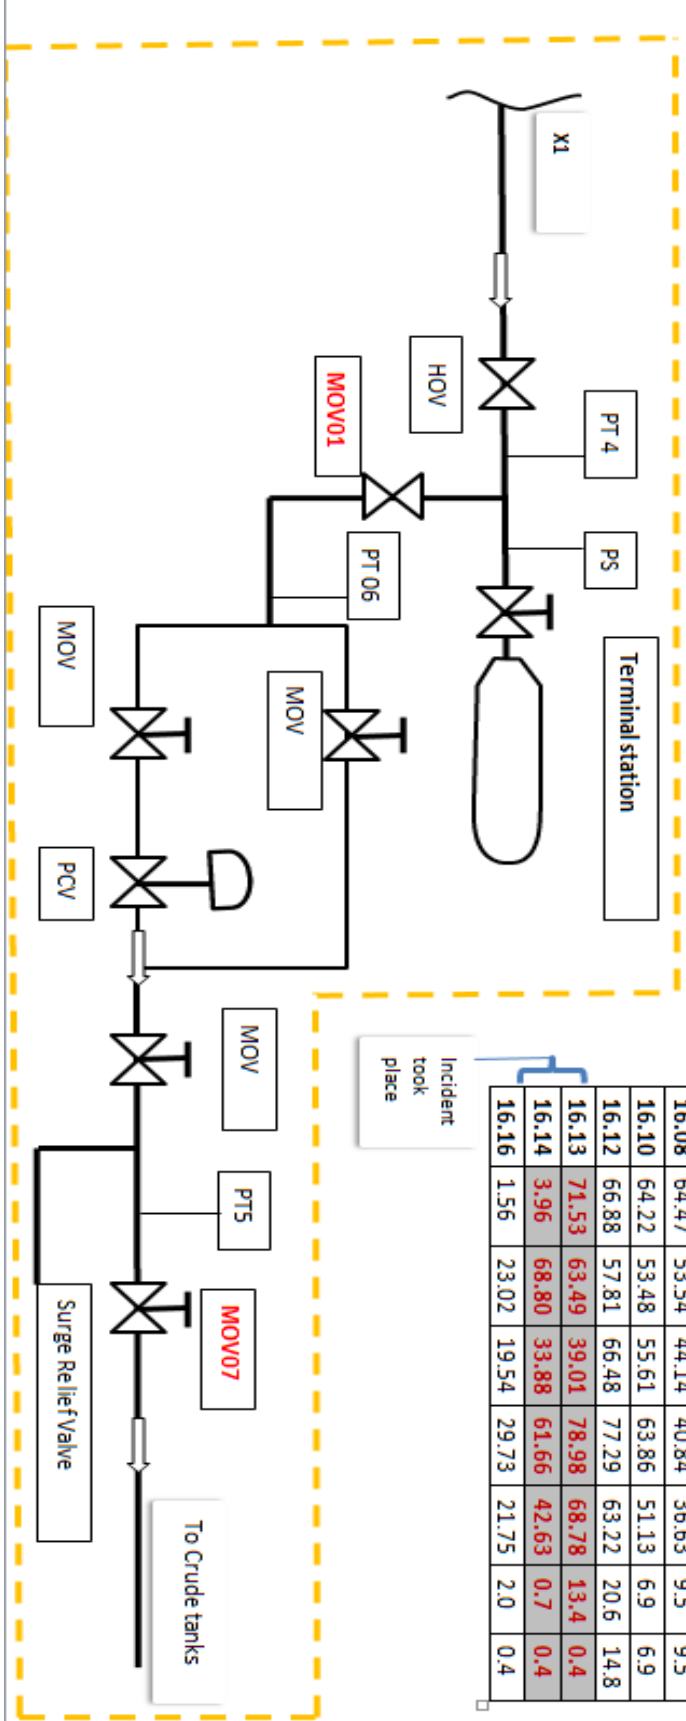
Annexure 'A'

- ✚ As per the SCADA event list, ESD was activated at Terminal station at 1604 hrs. Due to ESD operation, inlet valve (MOV 07 – with 60 seconds closure time) of crude tanks got closed at 1605 hrs. Thereafter, pressure before MOV07 increased from 3.5 kg/cm² to 19.1 kg/cm² at 1606 hrs. and consequently the surge relief system operated at 1607 hrs. Thereafter, the station inlet valve (MOV 01 – with 180 seconds closure time) also got closed at 1608 hrs., which isolated the mainline from the surge relief protection system installed in low pressure zone at Terminal Station. Consequently at 1613 hrs, pressure at terminal station inlet reached 69 Kg/cm². Sketch enclosed at Annexure "A".

Schematic diagram of pipeline section of a cross-country crude oil pipeline

MAOP = 74 kg/cm²

PS	SV1	SV2	SV3	Terminal station	
Time	PT0	PT1	PT2	PT3	PT4	PT5
16.08	64.47	53.54	44.14	40.84	36.63	9.5
16.10	64.22	53.48	55.61	63.86	51.13	6.9
16.12	66.88	57.81	66.48	77.29	63.22	20.6
16.13	71.53	63.49	39.01	78.98	68.78	13.4
16.14	3.96	68.80	33.88	61.66	42.63	0.7
16.16	1.56	23.02	19.54	29.73	21.75	2.0
						0.4

Incident took place

- (1) The ESD logic need to be carefully examined in light of the incident and may be further improved by giving a time lag of approx. 10 minutes between the closure of MOV-07 and MOV-01 so that MOV-01 should start closing after a gap of 10 minutes w.r.t. MOV-07, which will provide sufficient cushion for releasing the increased pressure in the line due to the impact of surge.

- (2) The surge relief tank capacity may be increased to 500 KL or a separate crude tank may be identified for taking the surge material with a minimum ullage of 500 KL at any given point of time.
