**CASE STUDY: FLASH FIRE DURING UNDERGROUND PIPELINE REPAIR**  
**MR. AK ARORA, AD(AI)**

### Case Study on “Flash Fire During Pipeline Repair Work”

There was a fatal flash fire at one of the crude oil pipeline terminal, during pipeline repair works. The incident happened during edge preparation i.e. grinding on the open end (plugged with bentonite clay) of the 42” NB pipe. The job was being executed on underground pipeline, around 3 m below ground level, in the excavated pit. The workers were deployed since previous night. The figure below depicts the site of the incident.

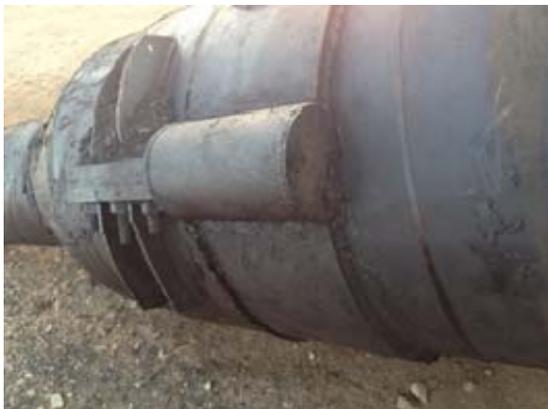
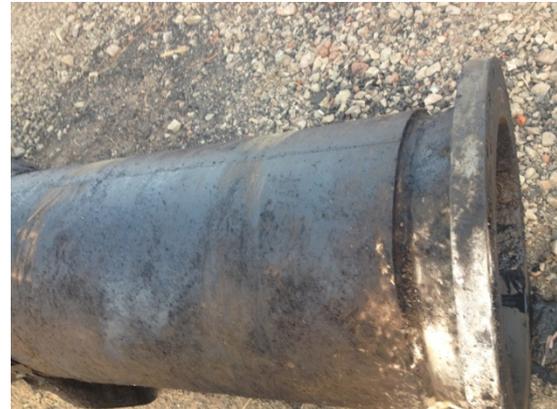
On the failed spool piece, two nos. of clamps on 42” NB already existed. Also the 24” NB portion of said spool piece had sleeve welded on the original pipe. This indicates this small length of spool piece, about 4.5 m length, had already been earlier repaired thrice in the past.

Sample thickness surveys were done at portion A and portion B of the header during above mentioned repairs. These sample surveys indicate significant loss of metal thickness.

Clamp repair of pipelines should be updated in the “As Built Drawings” and records of such clamps must be maintained.

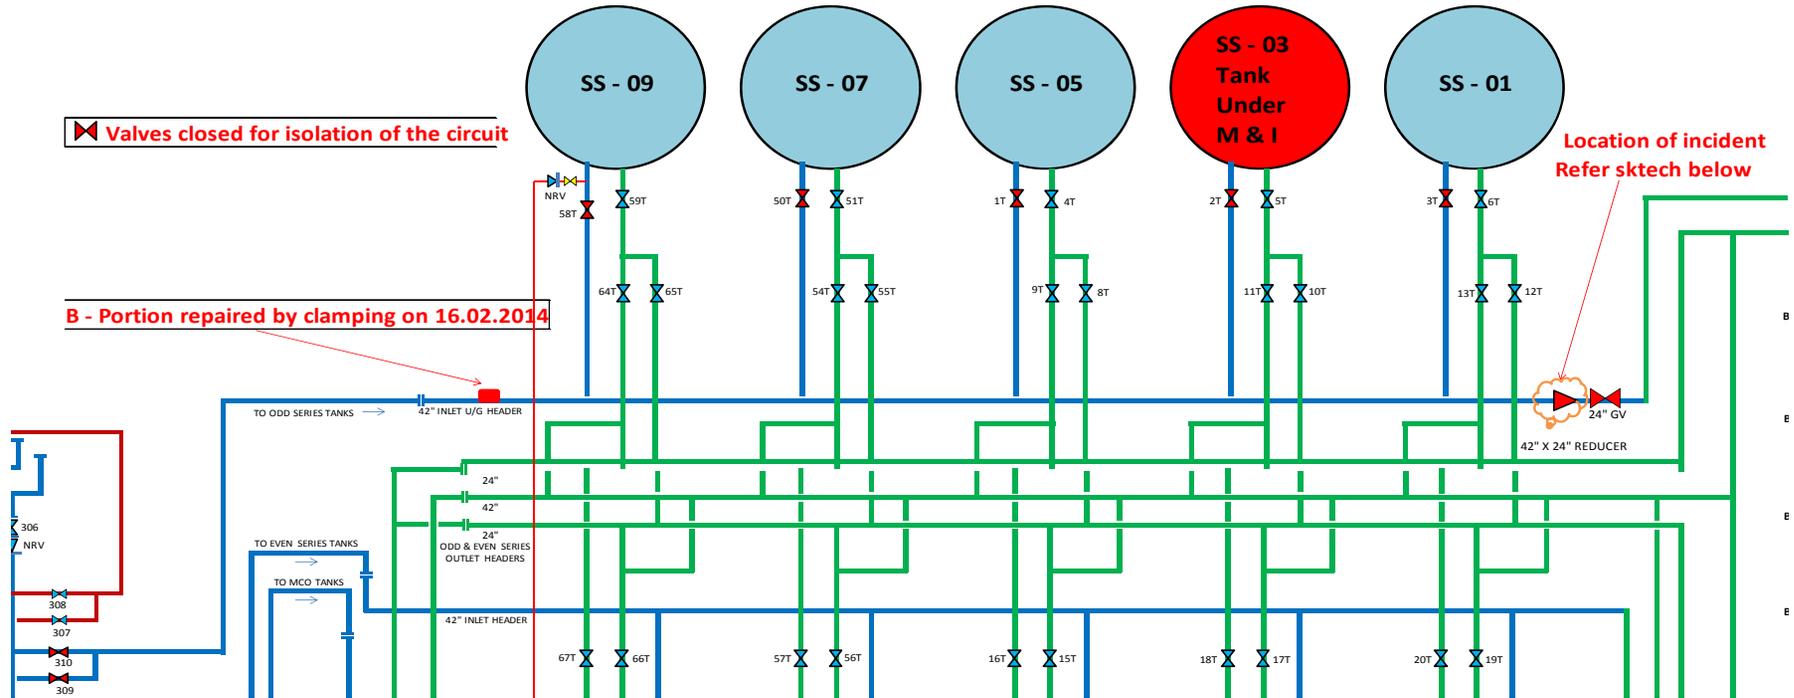
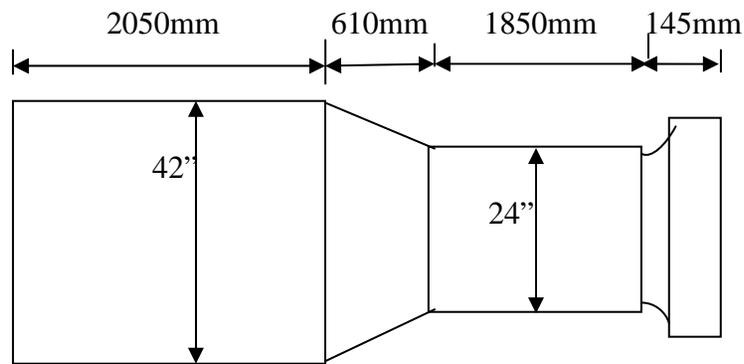
**Sketch & Details of Failed Portion—Location A**

The terminal houses 18 no. of crude oil tanks of 85000 KL capacity each, with allied pumping, pipelines & firefighting facilities. There are two receiving headers (each of 42”NB) for ten tanks. One of the headers feeds all odd series tanks (i.e. tank no. SS-1, SS-3, SS-5, SS-7 & SS-9) while the other feeds even series tanks (i.e. tank no. SS-2, SS-4, SS-6, SS-8 & SS-10). The schematic arrangement indicating exact location of incident is explained in Annexure-1.

- Isolation of the header by closing eight valves i.e. 5 nos. of individual odd series tanks, two nos. at the downstream manifold and one no. upstream valve (24” NB) as marked in Annexure-1.
- Evacuation of the crude from the header to tank SS-1 thru a temporary laid pipe.
- Removal of the corroded portion of the pipeline by cold cutting.
- Erection of the new spool piece (2 no. joints of 24” and 1 no. Joint of 48” NB) at fabrication yard.
- Welding of the newly fabricated spool-piece with the existing pipe end (42”NB).
- NDT of welding joint radiography and flange box up at other end with 24” NB valve.
- Charging Crude oil in the header, wrapping-coating of replaced portion and back filling.
