Case Study on Fire incident at Process Cooling Tower

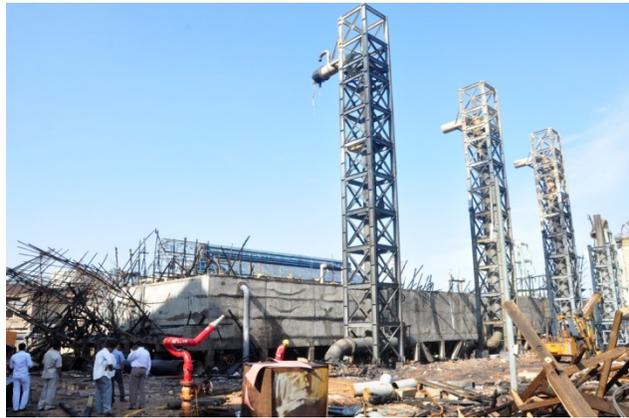
The incident happened during commissioning of the new cell. Soon after opening the cooling water return header valve to the new cell, there was an explosion and fire resulting in collapse of all the five cells of the cooling tower. The incident resulted in serious burn injury and fatality to a number of persons working in the cooling tower area.

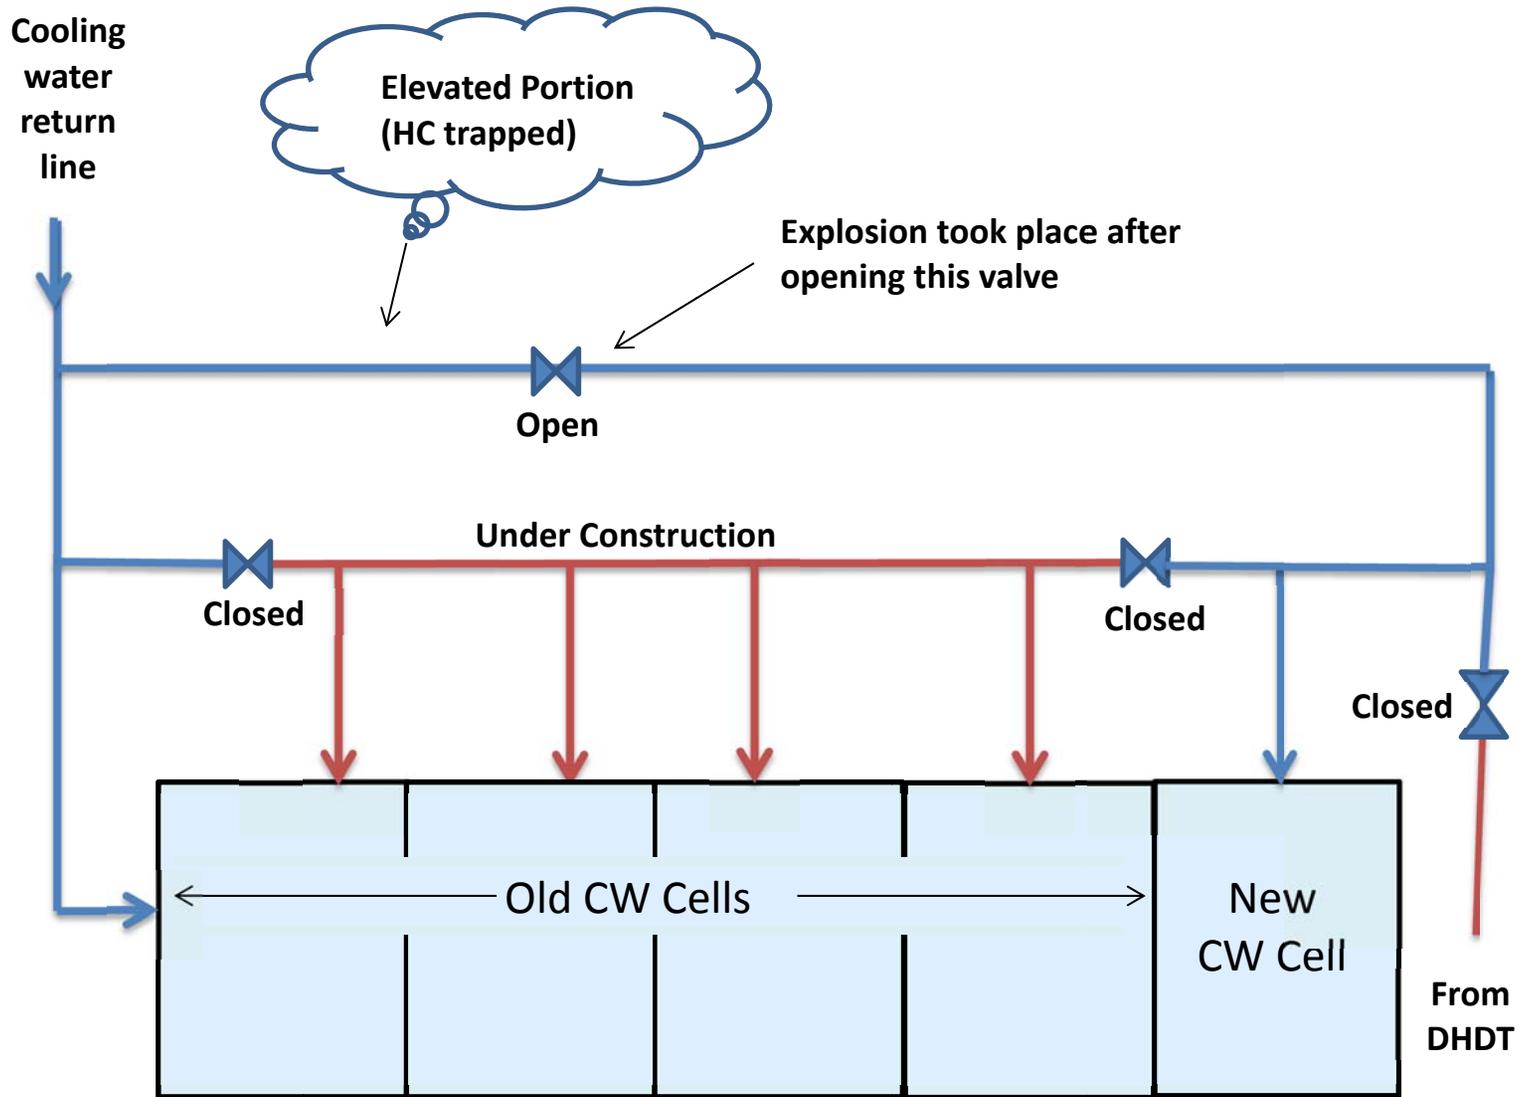
Fig. - 1 : Sketch of Cooling water lines

The hot work of these headers and riser pipes were going on at the time of incident. On the date of incident, total 16 jobs were going on, out of which hot job permits were issued for 9 jobs. **The explosion took place after opening of the valve on the CW return line connecting to riser of new cell** (shown in Fig 1).

- There is distinct possibility of entrapped / accumulated light hydrocarbon in the portion of the new line since it is located at an elevation and that there was no escape route for this entrapped hydrocarbon as the other end of the header was closed by valve.
- The entrapped hydrocarbon gushed into the Cooling Tower as soon as the CW return line valve to the new cell was opened. The hydrocarbon got ignited by the spark of welding jobs being carried out nearby causing explosion and major fire. The wooden structure of the Cooling Tower got ignited in the process which continued for about 45 minutes till the fire was extinguished by F&S personnel.
