**OIL INDUSTRY SAFETY DIRECTORATE**

**CASE STUDY FOR RIM SEALS LIGHTNING FIRE OF FLOATING ROOF TANKS**

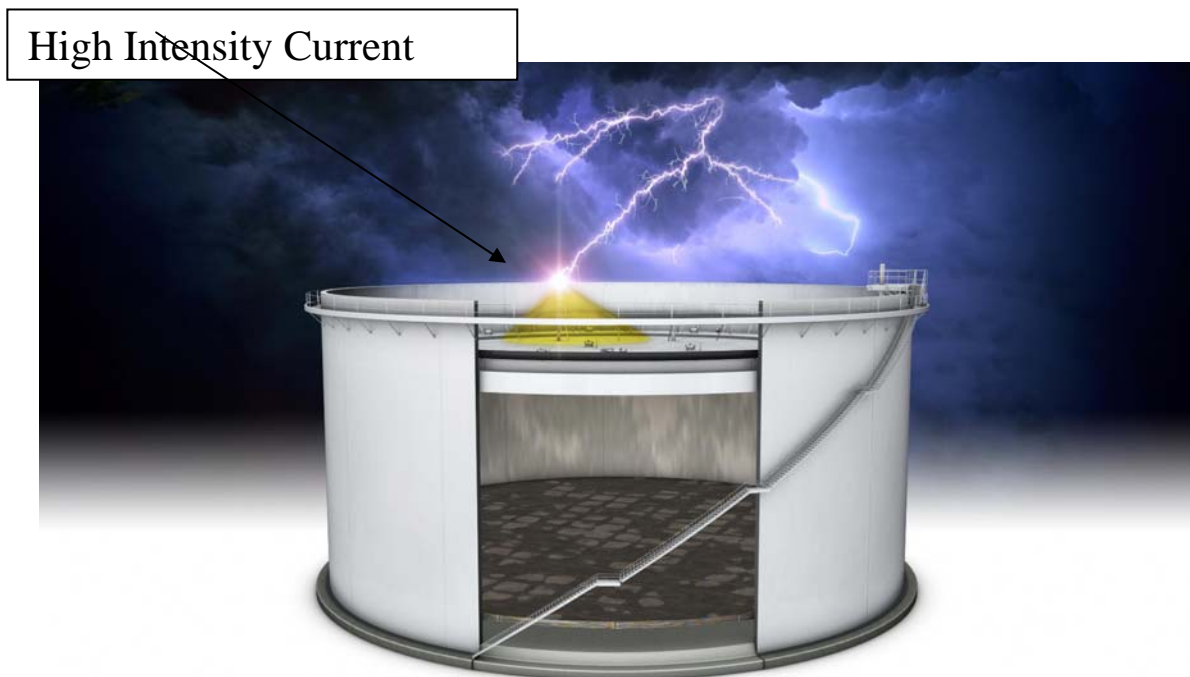
**Figure-1: Typical Lightning Strike when the roof is at high elevation**

- (i) It is clear that the source of ignition was lightning which coupled with the presence of hydrocarbon vapour in the flammability range resulted in the rim seal fire and explosion. Roofs of both the tanks were at highest elevation as the tanks were almost full during the lightning strikes. The hazards from lightning tend to be worse when the tank roof is high (***Refer API/EI research report on Verification of lightning protection requirements for above ground hydrocarbon storage tanks -first edition 2009***) as the lightning strike will easily jump from shell to roof, creating severe sparks at shunts which are not tightly pressing against the shell. Typical Lightning Strike when the roof is at high elevation is shown as Figure-1.

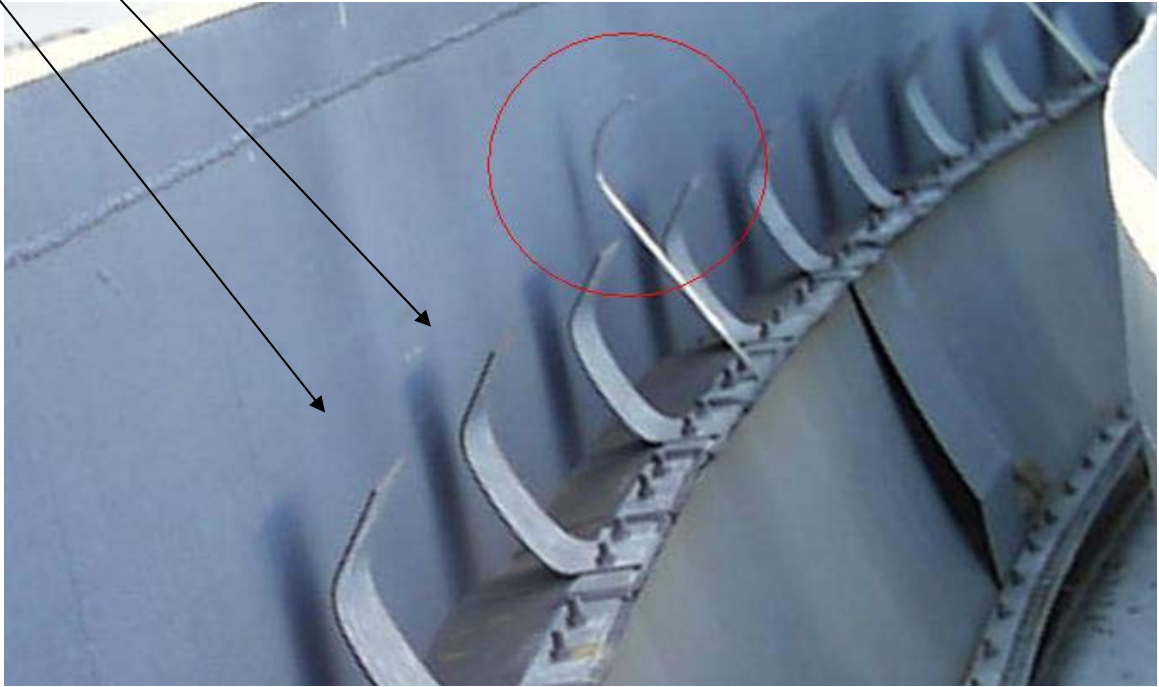
Figure-2: Typical gaps which can cause arcing between shunt & the shell

seal and the tank shell will allow lightning initiated sparks to fall into the vapour area between secondary and primary seal. Typical gaps which can cause arcing between shunt & the shell is shown as Figure-2. In case of the affected tanks (SS-004 & SS-001) gaps which were existing between the secondary seal & shell surface emitted enough vapours to get ignited because of shunt generated sparks.

Gaps in Shunts & Shell

- ✓ **Installation of submerged shunts** every 3mtrs around roof. In case of submerged shunt any sparks that occurs is within the liquid and do not have the necessary air for ignition to take place. When retrofitting existing tanks with submerged shunts, the above deck shunts should be removed.
