Case study on major fire incident due to failure of crude booster pump

-S/Shri S.K. Bagchi, AD (Asset Integrity) & M.K. Dutta, AD (Process)

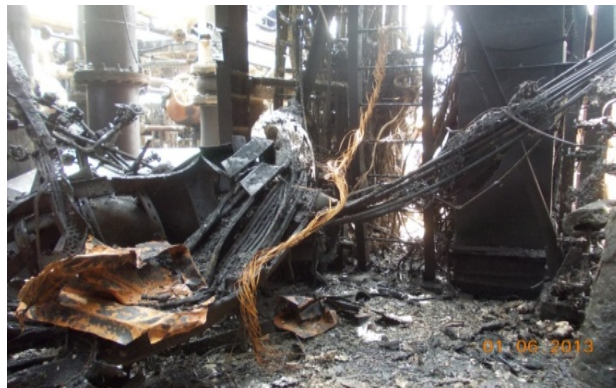
- Instrumentation and electrical cables of the nearby area were found fully burnt and damaged.

Burnt Instrument & Electrical cables

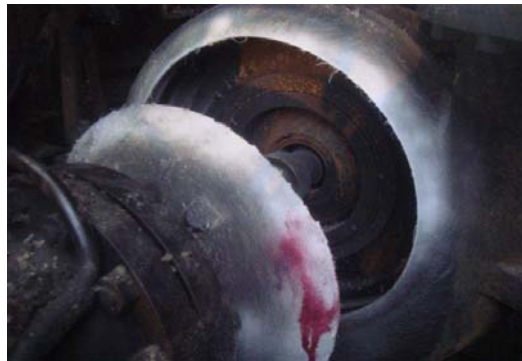
- a. Casing of crude booster pump was totally damaged & torn into 02 pieces.
 - b. The casing plate was cut circumferentially; there is no welding joint in the casing at the location of failure.

- c. The thickness of the casing at the detached / cut location throughout the circumference is about 1.0 mm.
 - d. Such failure of the casing plate into two pieces is a clear indication of mechanical failure of the casing due to rubbing of impeller against the pump casing.

Casing plate of crude booster cut circumferentially by rubbing action of impeller.

Failure of the nut caused the impeller to move towards the suction end (casing side) and touch the casing plate by the hydraulic pressure on the back of the impeller. **This resulted in significant rubbing action of the impeller against the casing plate and the impeller acted like a cutting tool to cut the casing plate circumferentially into two pieces.**

- 1) During pump overhauling, through inspection of the locking arrangement of the impeller with the shaft must be done to check for any deterioration or abnormality. It is to be ensured that impeller locking is done with appropriate torque and the same must be properly supervised for all critical pumps.

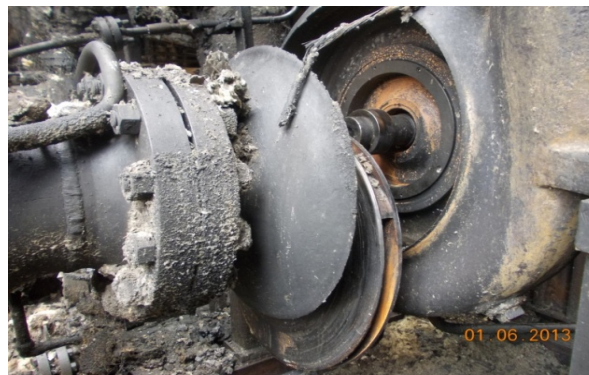
As a result, the impeller of the pump got detached due to shearing of the shaft near the lock nut. The friction between impeller and the casing is a possible source of spark generation to ignite the crude oil.

Detached Impeller from the shaft

- Failure of Lock nut of the Impeller is due to any one or combination of following :
 - (a) Axial vibration resulting in Load on the Lock nut leading to its failure.
 - (b) Inadequate tightening torque on the Lock nut at workshop during the overhauling.
 - (c) Integrity failure of the washer of the locknut or thread damage.

- 1) The root cause of the major fire is the failure of Lock nut of the Impeller. Failure occurred due to any one or combination of following:
 - (a) Axial vibration resulting in **Load on the Lock nut** leading to its failure.
 - (b) Inadequate **tightening torque** on the Lock nut at workshop during the overhauling.
 - (c) **Integrity failure** of the **washer** of the locknut or thread damage
