Case study- Fatal Incident at Installation

Brief of the Incident:

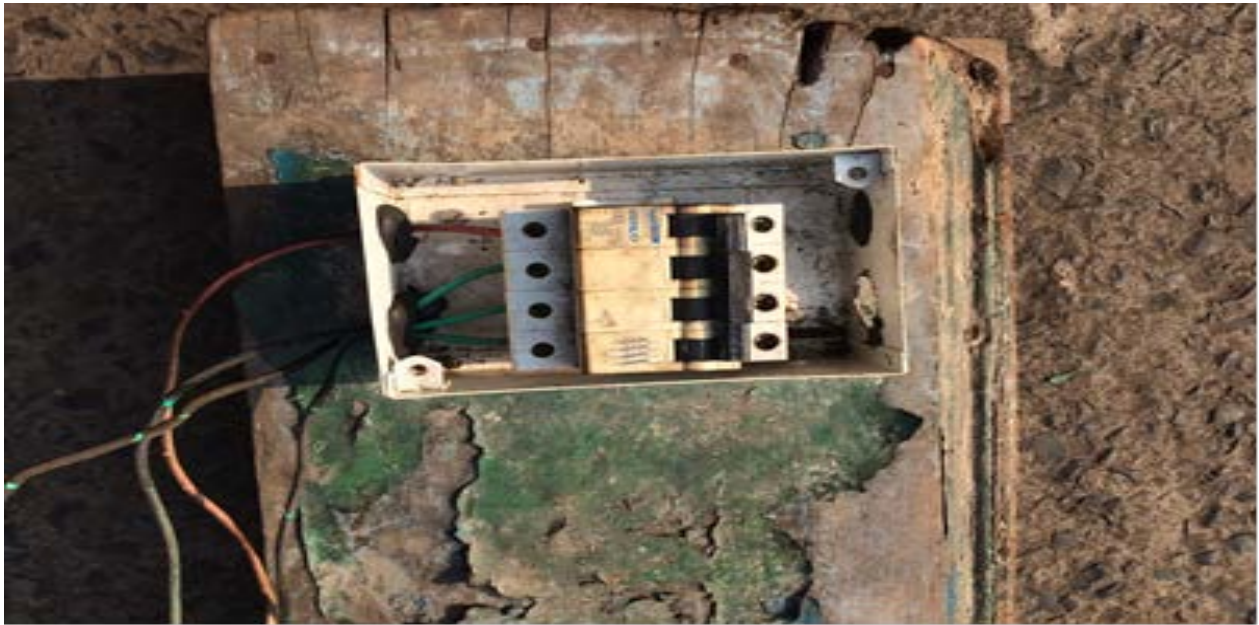
Non FLP switch Board –source of Ignition

Opening of both side manhole covers of MS tank without following any laid down procedure coupled with carelessness & without opening top manhole cover for aeration. Above has caused accumulation of MS vapors in the vicinity of tank and around the motor/non FLP electrical switch board

Due to sudden stoppage of running motor, spark generating from non FLP switch board ignited the rich MS vapors resulted in explosion and fire.

- Project works being executed at operating locations should not compromise the safety infrastructure of the location
- Usage of non-FLP junction box / switch board should be strictly prohibited inside tank farm area/operating area.

- Electrical equipment should strictly conform to the Hazardous Area Classification (OISD-STD-113)
- MOC should be processed and approved by the appropriate authority before undertaking any job for which laid down procedures/SOPs are not available.
