CRUDE OIL SPLASH AT PIPELINE PUMP STATION IN INDIA

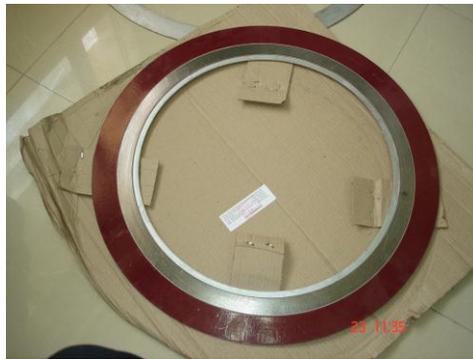
4.2.4 Since there was no inner ring found on the retrieved gasket which otherwise provide securing the gasket material in place and also add to the strength of the gasket, failure of gasket in this case could be due to non-availability of inner ring.

Inner Ring of the gasket

- 5.2 After replacement of gaskets, the pipe section should be hydro tested to meet the MAOP / Design pressure requirement.
- 5.3 All the flanges where thermal insulating material is to be provided should be provided with inspection window, so that at least once in a month, inspection of flanges for any leakage can be checked.
- 5.4 It shall be ensured that all gaskets are fitted with an inner metallic ring.

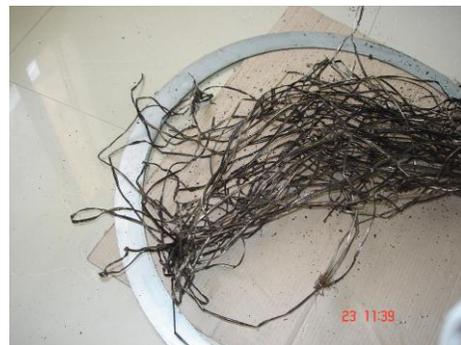
4.1 The failure of metallic gasket of higher pressure rating (in this case 600#) capable of withstanding a design pressure of 101 Kg/cm² is very rare. At a pressure of ~ 70 Kg/ cm², failure in gasket occurred in the segment of 11 to

1 “O” clock position of the flange connected to Motor Operated Valve in which part of worn out gasket materials also came out. Such phenomenon indicates either poor quality of gasket or poor workmanship during installation.

4.2.2 During installation of gaskets, while tightening the valve flange stud and bolt, the gasket could have been damaged. With the passage of time, during pigging, spiral wound materials of the gasket might have given away resulting in weakening the flange joints and subsequently it failed.

Damaged gasket (w/o inner ring)

5.1 All the station piping gaskets of the flanges to be checked for appropriate class / pressure ratings and of reputed make. While

replacing gaskets, material and work to be inspected / supervised by competent person.
