CRUDE OIL SPLASH AT PIPELINE PUMP STATION IN INDIA

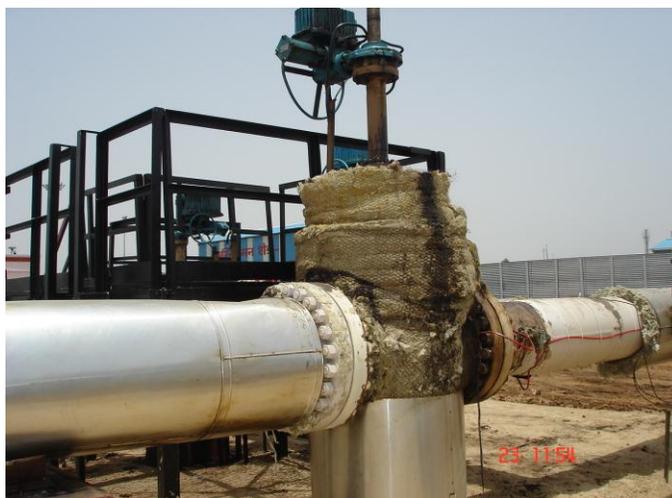
Oil Company's pipeline installation is spread over an area of 60,000 square meters. It is surrounded by Industrial area on the north and east side. This pipeline pump station installation is one of many such pump station for about 1200 km long crude oil pipeline. This crude oil pipeline delivers crude for one of the high capacity refinery.
